**BOND CHARACTERISTICS OF OVERLAYS PLACED  
OVER BRIDGE DECKS SEALED WITH HMWM OR  
EPOXY**

**Report No. UC-CII 98/02**

**July 1998**

**CINCINNATI INFRASTRUCTURE INSTITUTE**

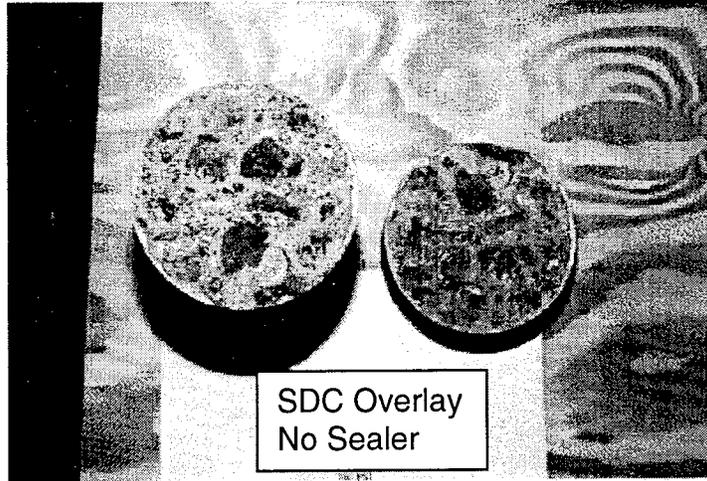
Figure D.7(a) Direct shear test for a specimen without sealer at the Interface. Failure occurred in the base concrete. Note the broken aggregate in the overlay and base concrete.
